# Michigan Central Station

*Transformation of an Icon*

DETROIT, MICHIGAN

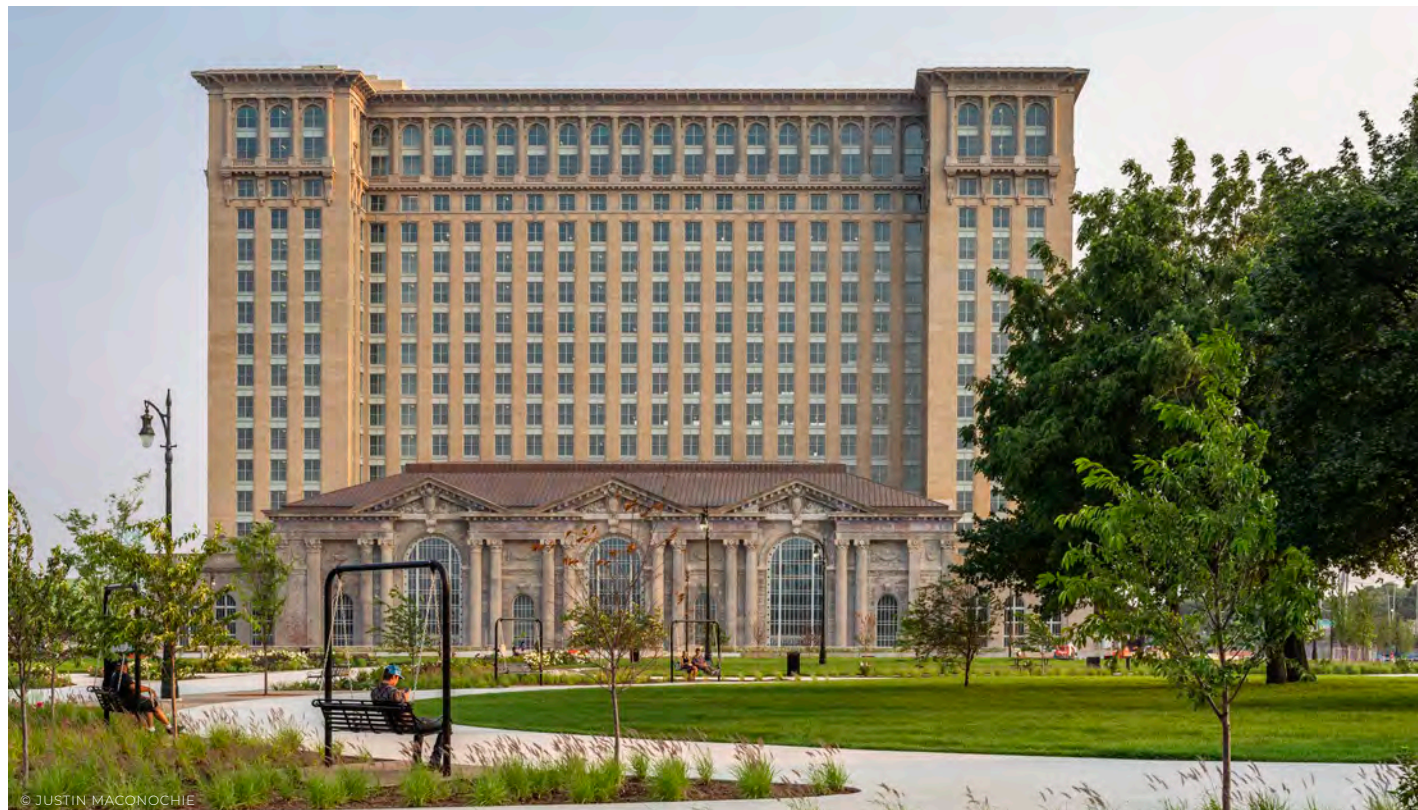
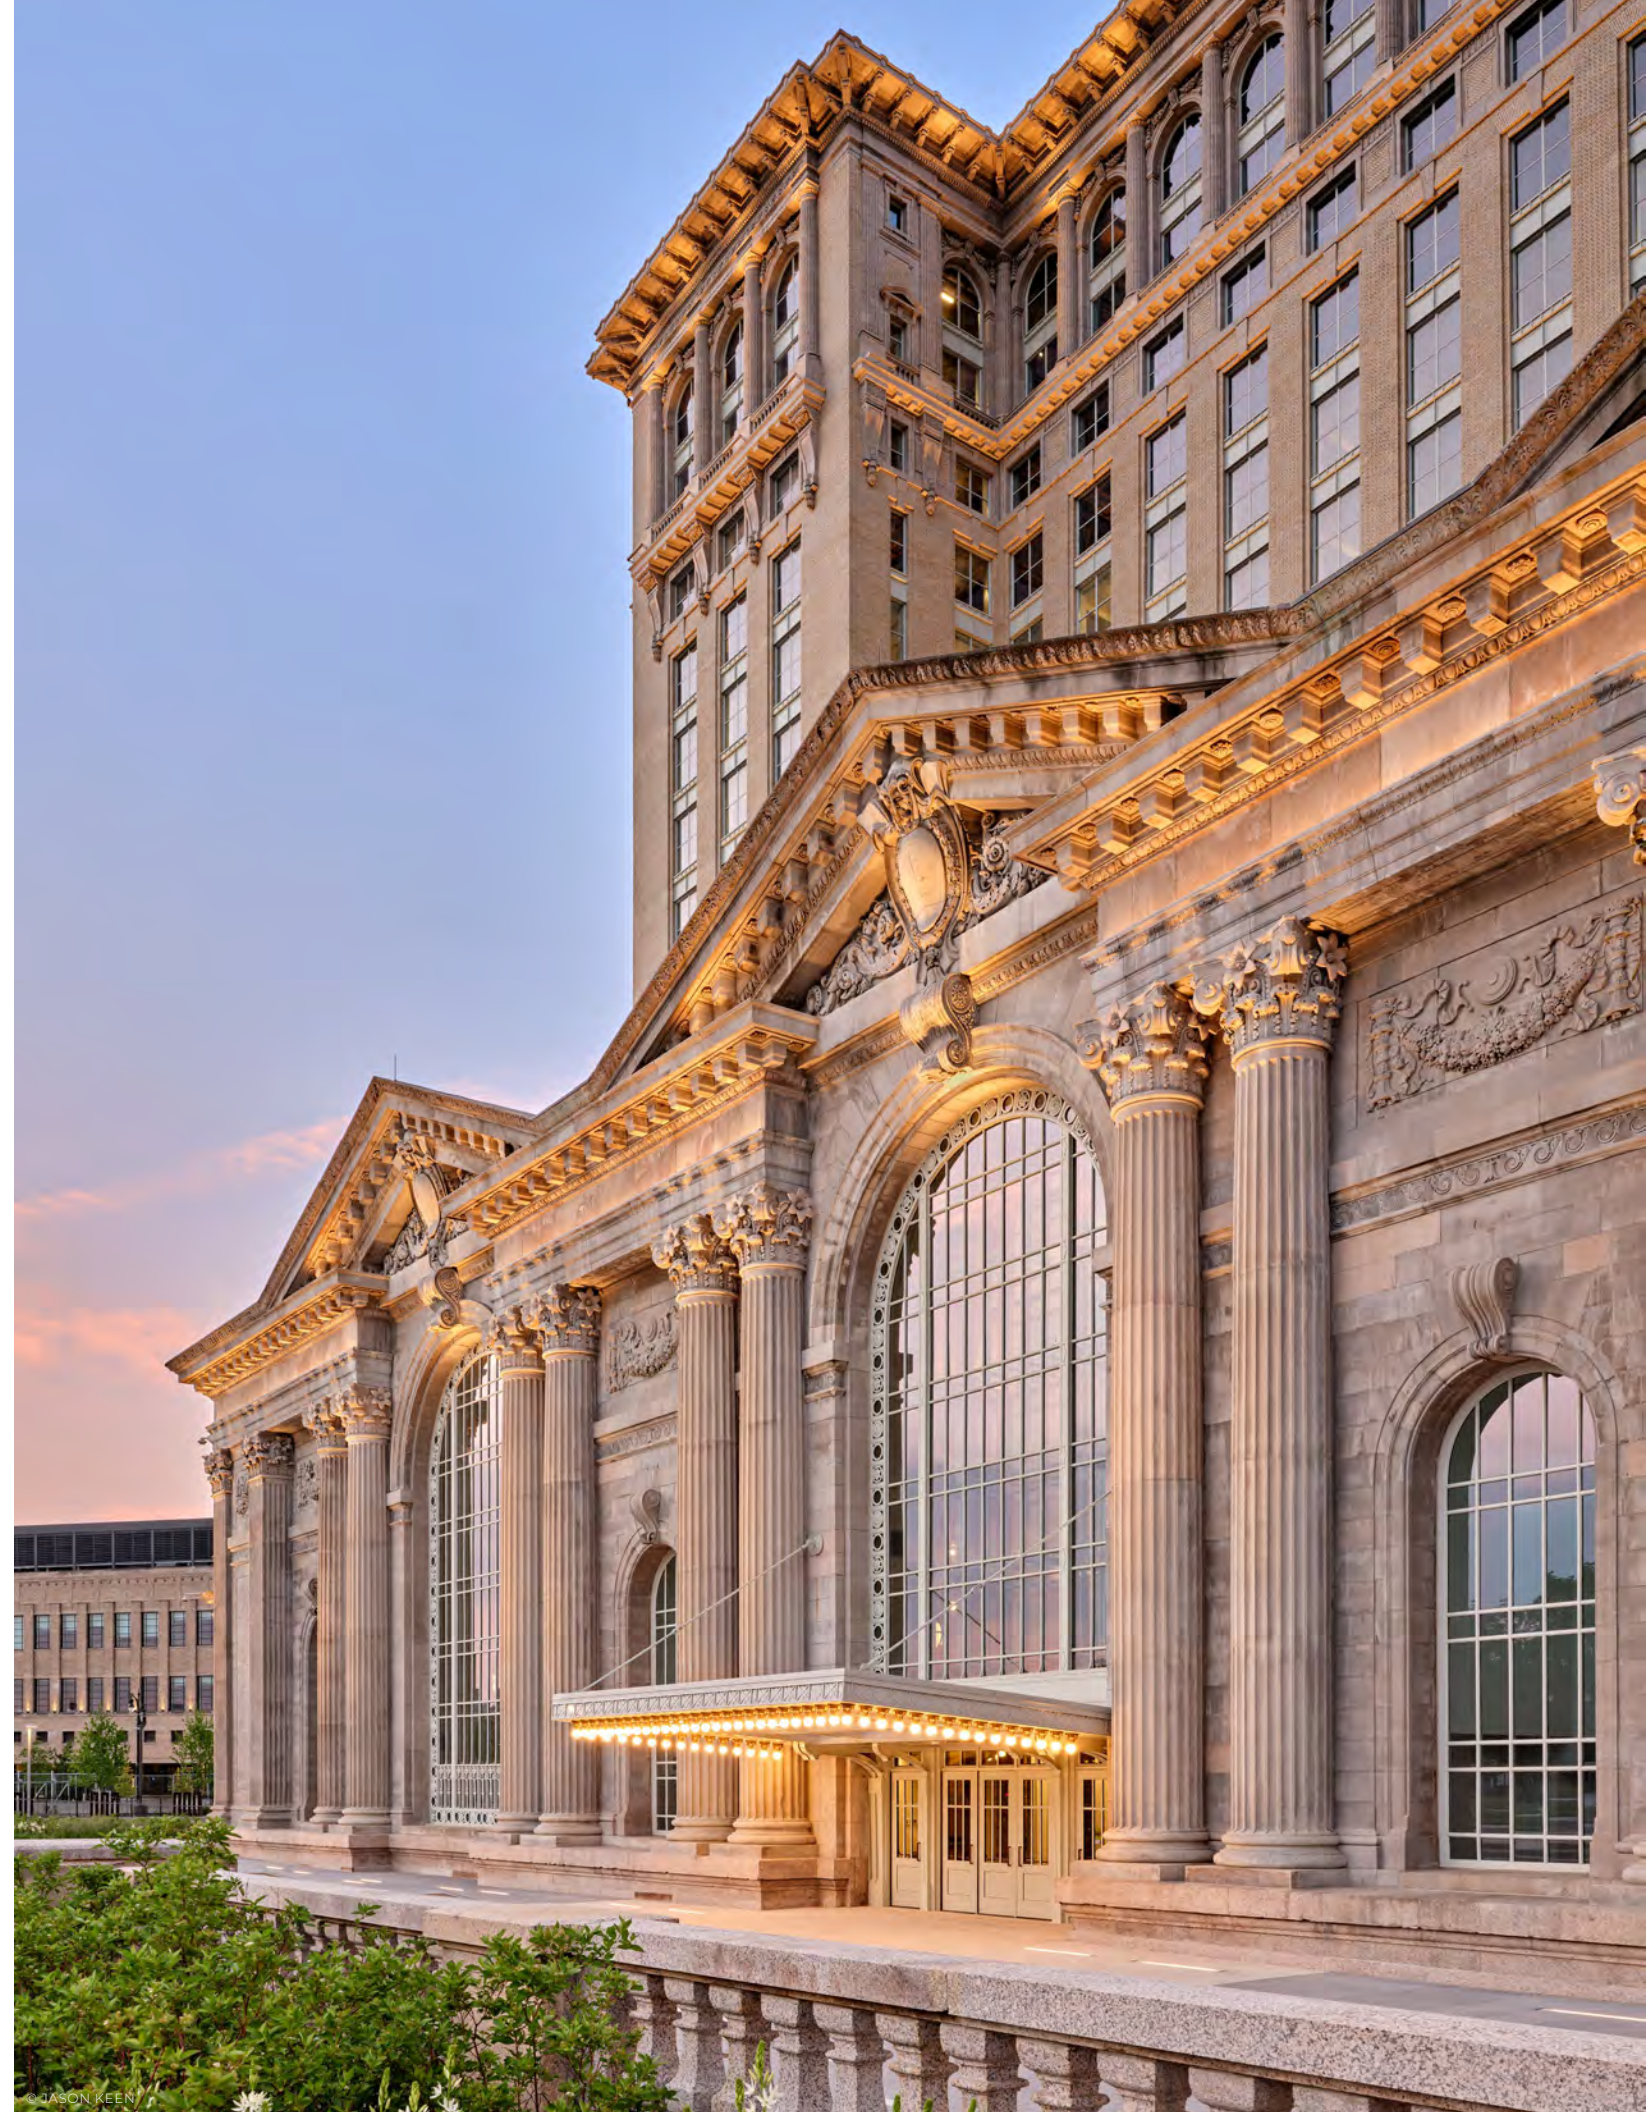
## EXTERIOR

Michigan Central Station is a symbol of Detroit's vibrant industrial age. Approaching the building's entrance on the north side, you will see a Beaux-Arts station that looks very much as it did when it opened in 1913.

- **Façade:** The base of the building is clad in textured limestone. Where stone was missing or too badly damaged from years of water infiltration, replacement stone was sourced from the original quarry in Indiana from blocks extracted at the time the station was originally built.

- **Pediments:** Three pediments along the north façade and entry plaza feature mythological creatures.
- **Columns and Capitals:** Along the grand hall façade, to the north stand 40-foot-high stone columns with ornamental capitals at the top. Nine of the capitals are original to the building, while five were replicated to match the originals. A master stone carver spent more than 400 hours hand carving one new stone capital, which was then scanned and used as a model for CNC machines to replicate the last four capitals. In time, these new capitals will age to match the gray tone of the existing limestone.

- **Entry Canopy:** Using historic drawings, Quinn Evans recreated the missing entry canopy. The new canopy appears much as it did when the building first opened, but now includes a skylight that gives glimpses to the monumental window and stonework above.

- **Office Tower:** A brick and terracotta-clad tower rises 18 stories above the ground floor. All the terracotta detailing, from the Juliet balconies to the top cornice marked with double corbels, has been completely restored.

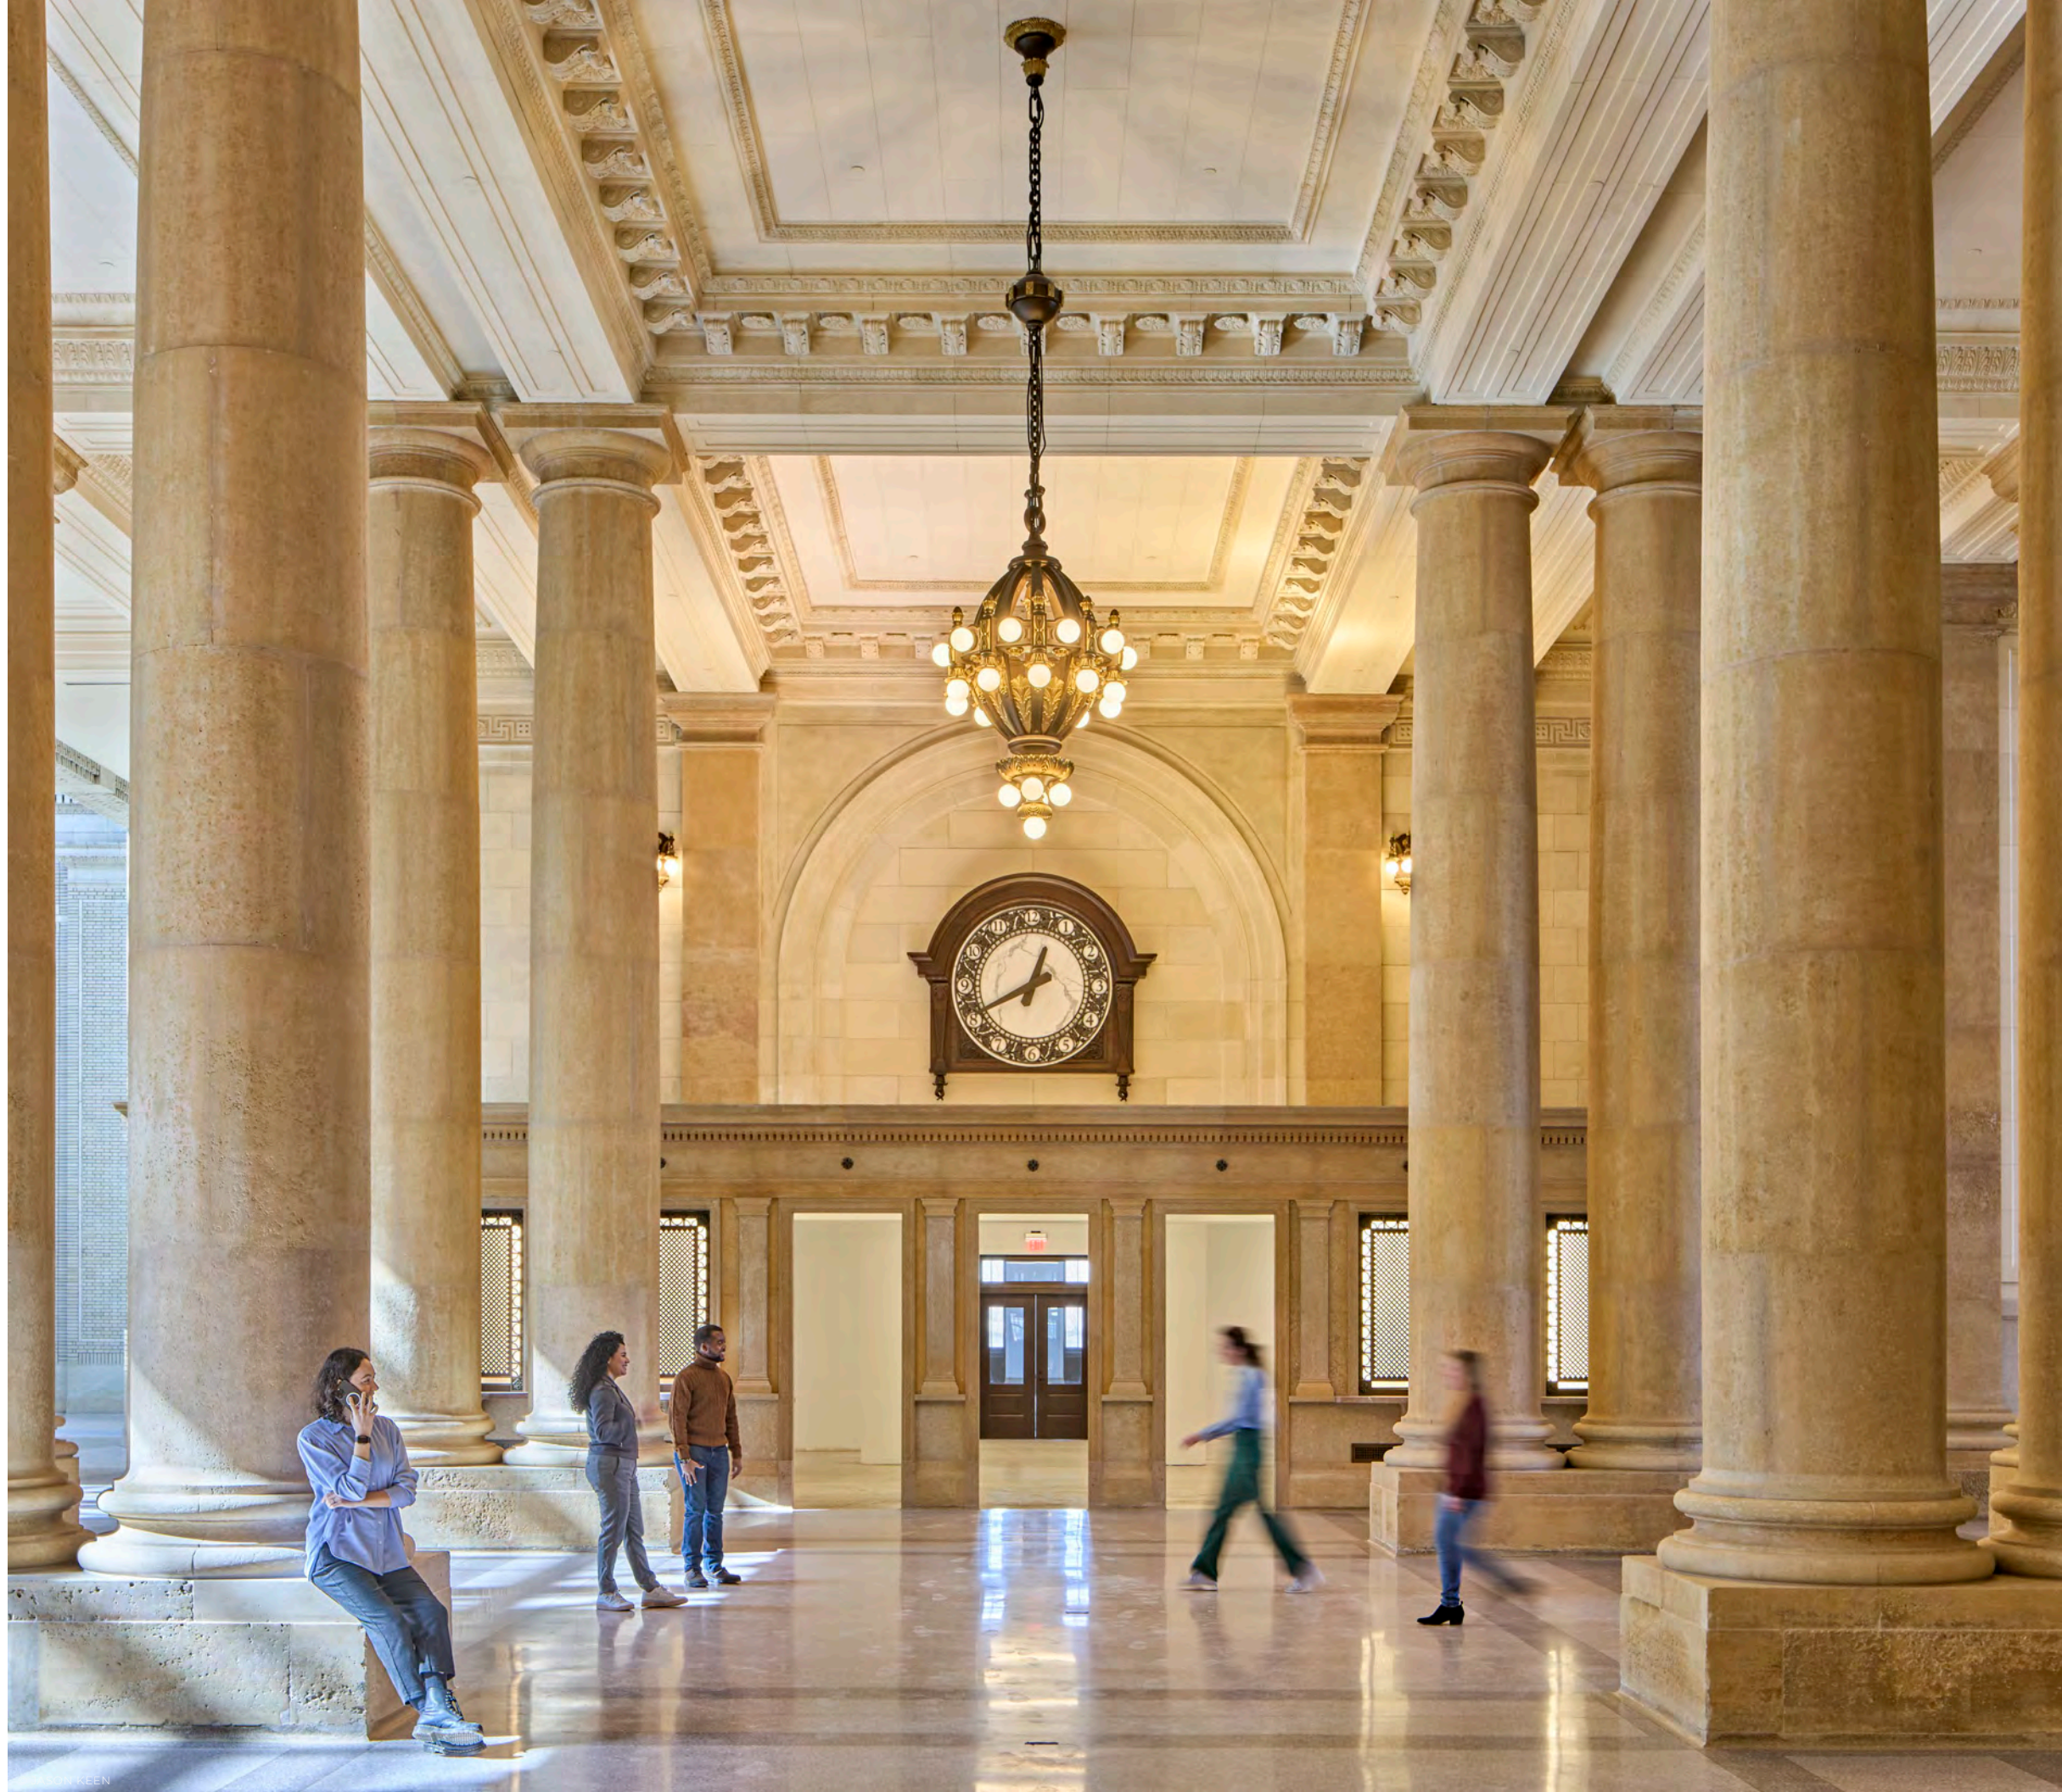
## TICKET LOBBY

- **Columns:** The columns in the ticket lobby are clad in Mankato stone. Their unique texture was created by exposure to the elements while the station was vacant and deteriorating.
- **Clock:** The historic clock was recreated with hand-carved wood elements and replicated cast iron decoration.
- **Lighting:** The chandeliers and sconces throughout the Ticket Lobby, as well as the Grand Hall, Arcade and East Elevator Lobby, were recreated using the historic shop drawings found at the state archives and various detail elements that were returned to the site.

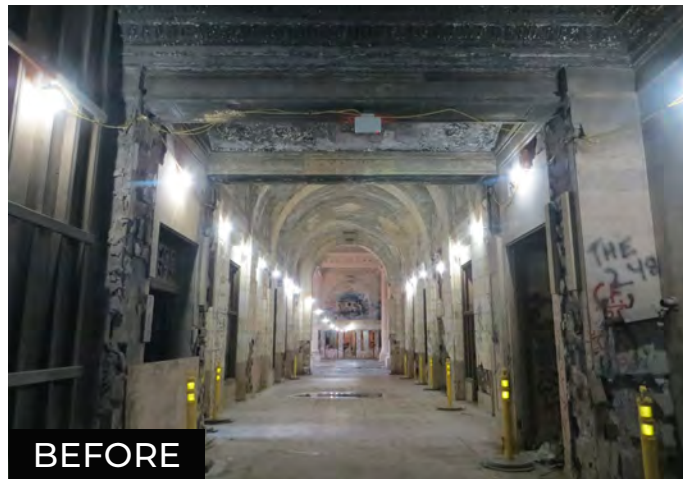
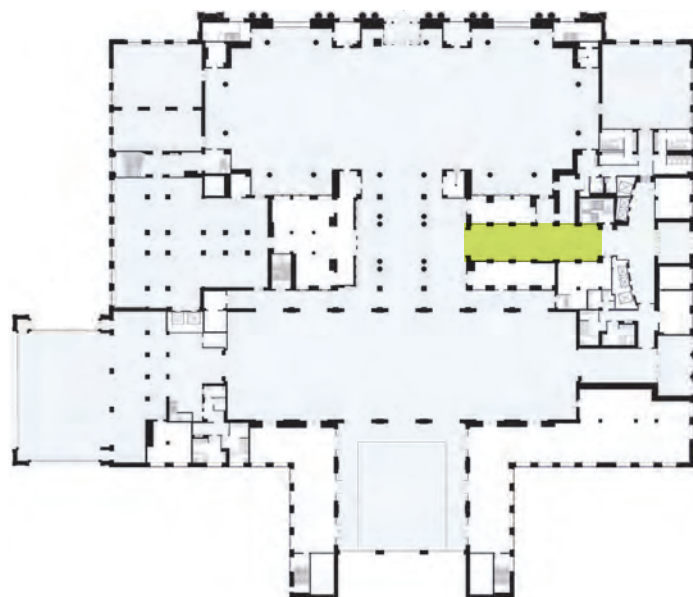
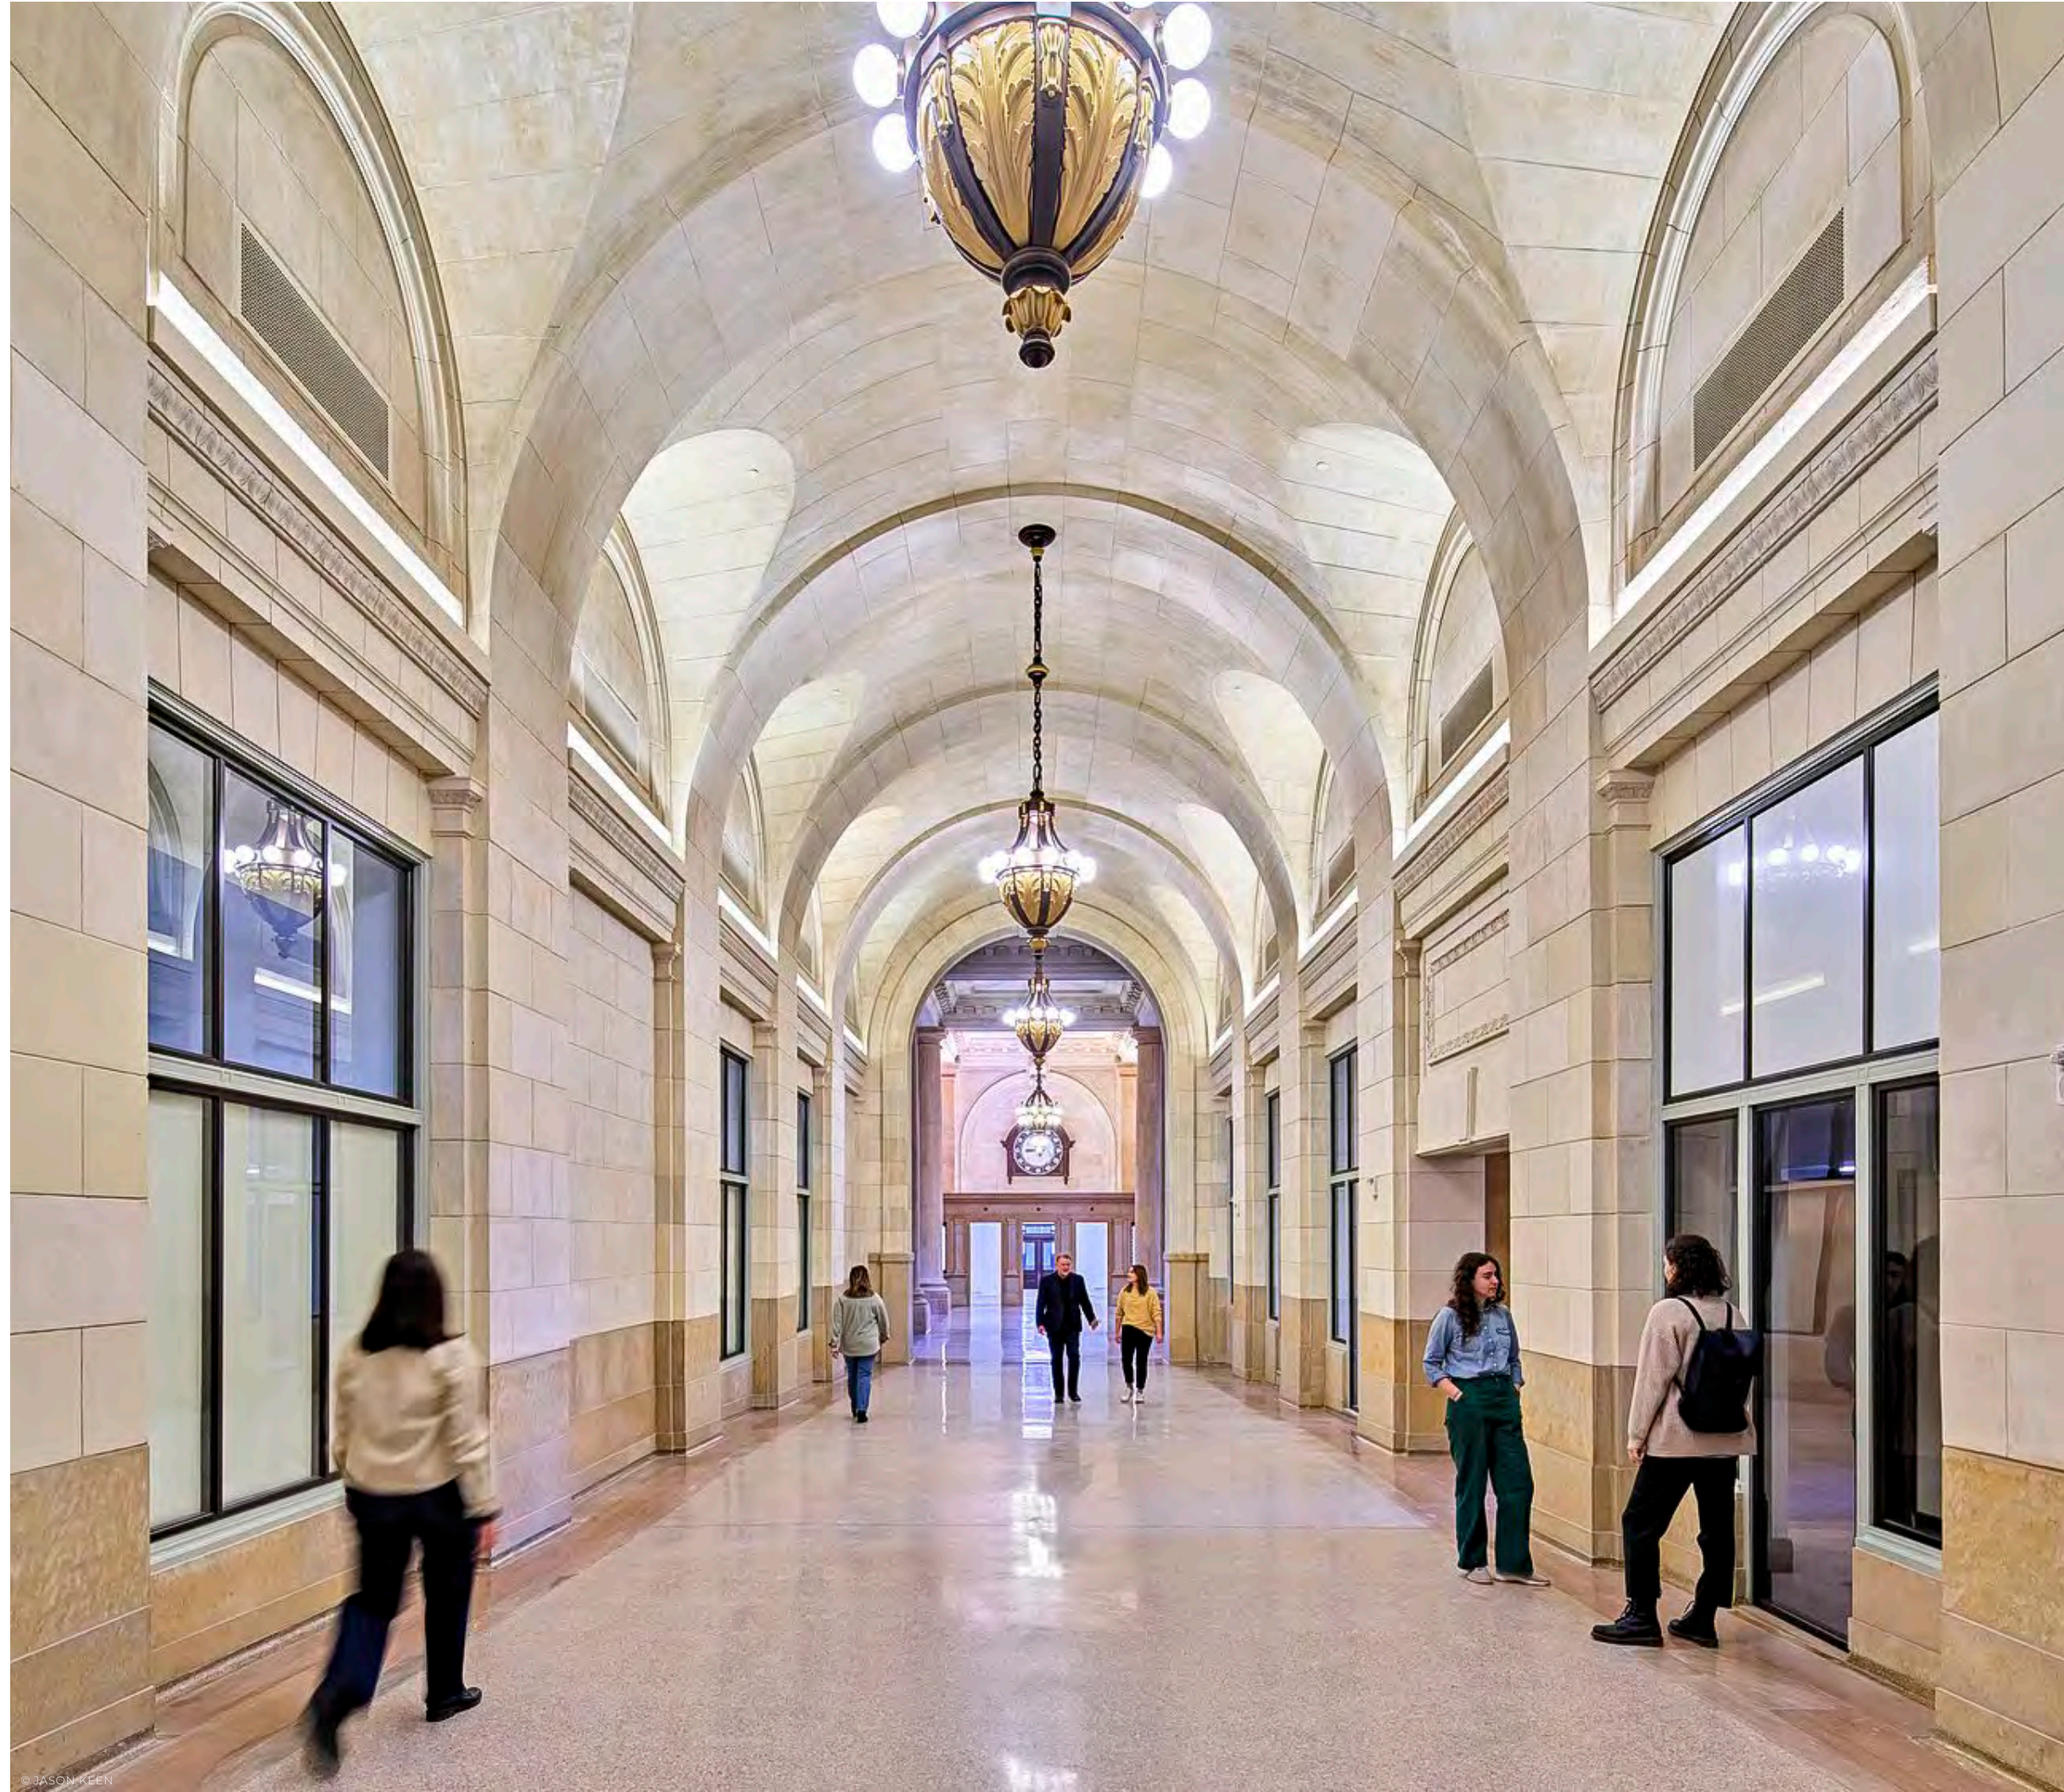
## ARCADE

- **Plasterwork:** Except for the stone base, the Arcade walls and ceiling are clad entirely in plaster made to look like stonework. Almost all of it is original—unlike the plasterwork elsewhere on the ground floor, it was protected from the elements by the tower structure above.
- **Storefronts:** The openings along the Arcade are the original cast iron storefront frames. One opening provides a passageway to the Grand Hall.

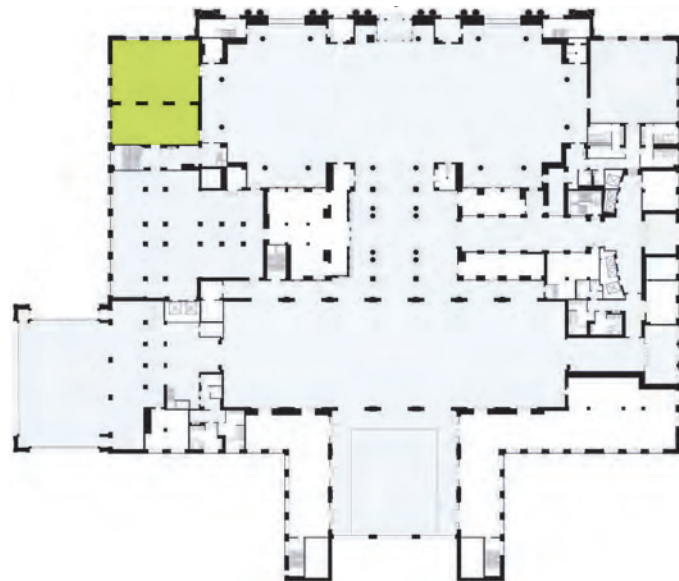
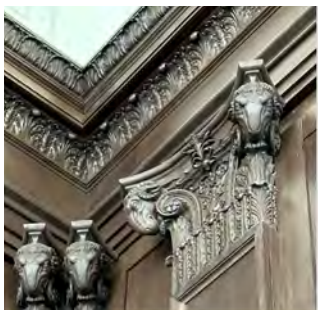
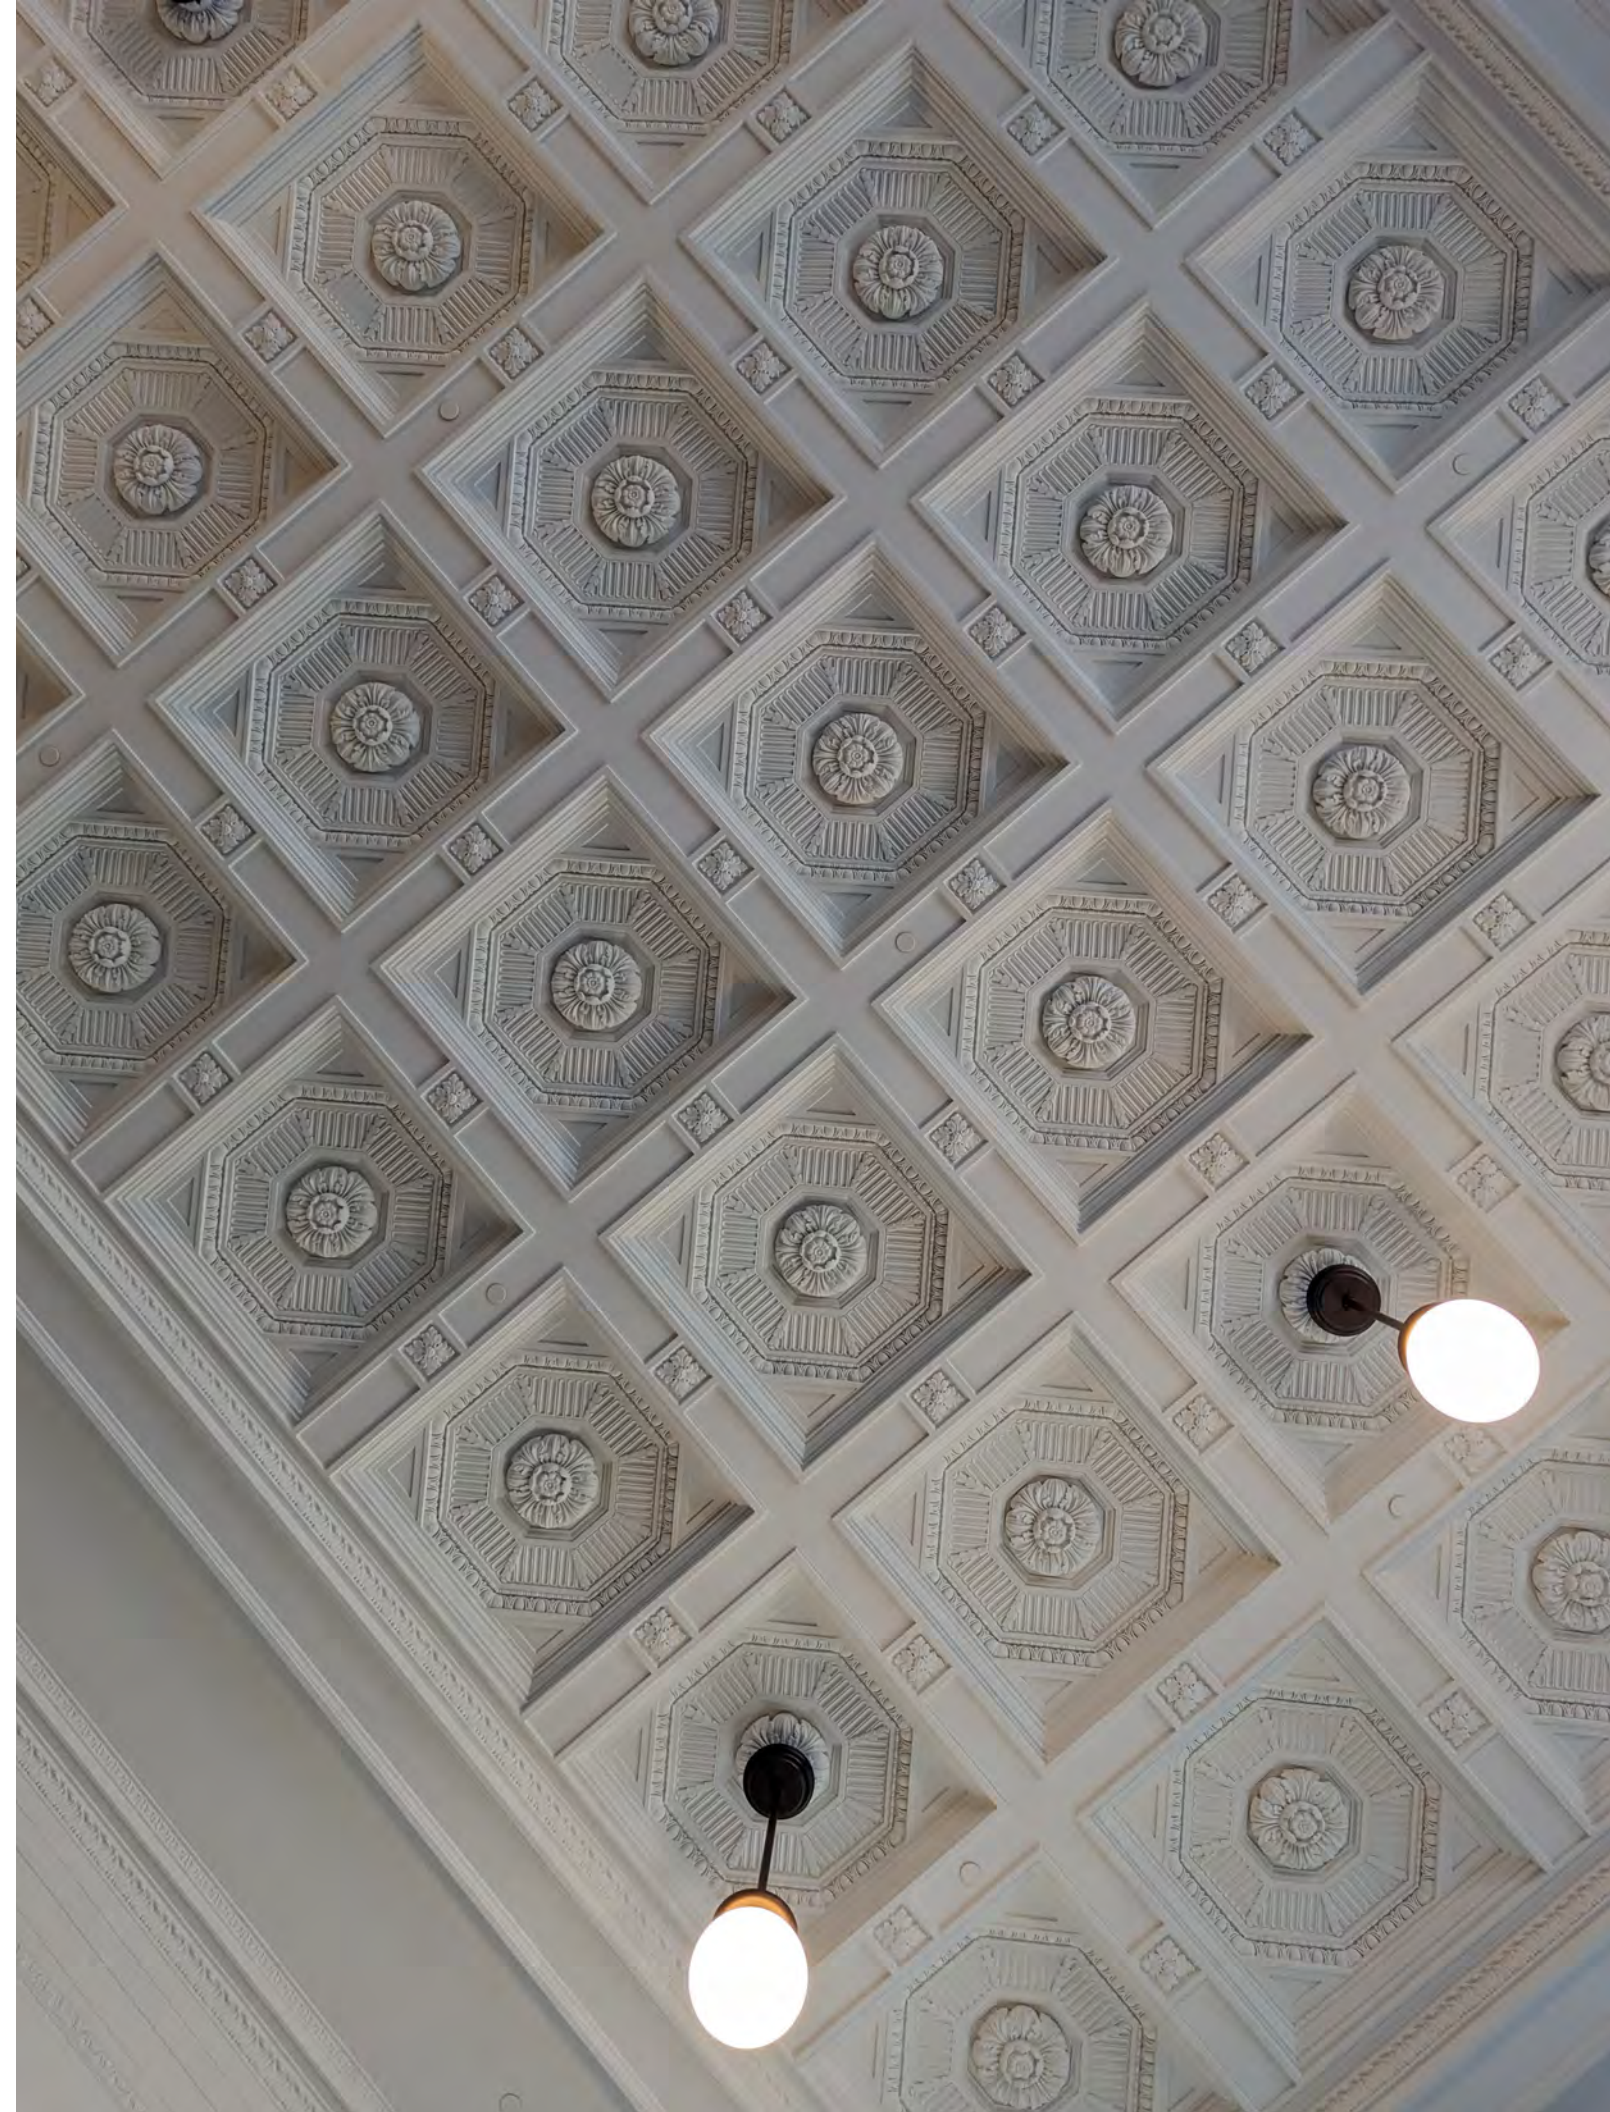
## READING ROOM

- **Ram's Head Capitals:** There are 44 ram's head capitals topping the pilasters. All had been missing, but one original was located which allowed for the replication of the rest of these unique capitals in the Reading Room and Tea Room.
- **Ceiling Rosettes:** Nearly all of the intricate rosettes that span the ceilings in the Tea and Reading Rooms went missing while the building was vacant. One rosette survived, which enabled conservationists to create a mold and replicate the other 66 rosettes.

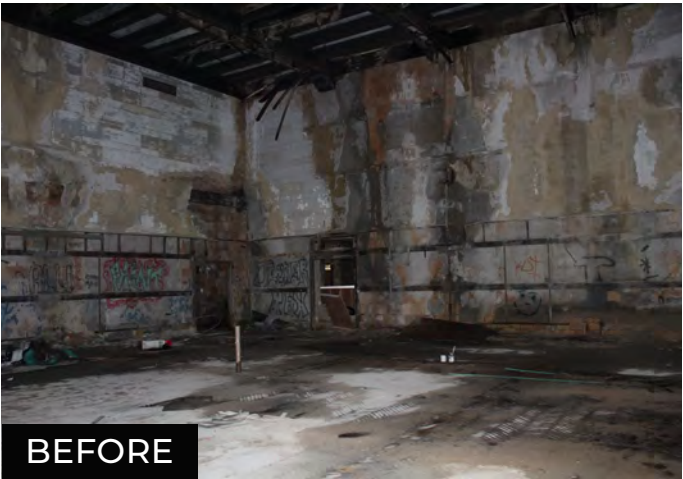
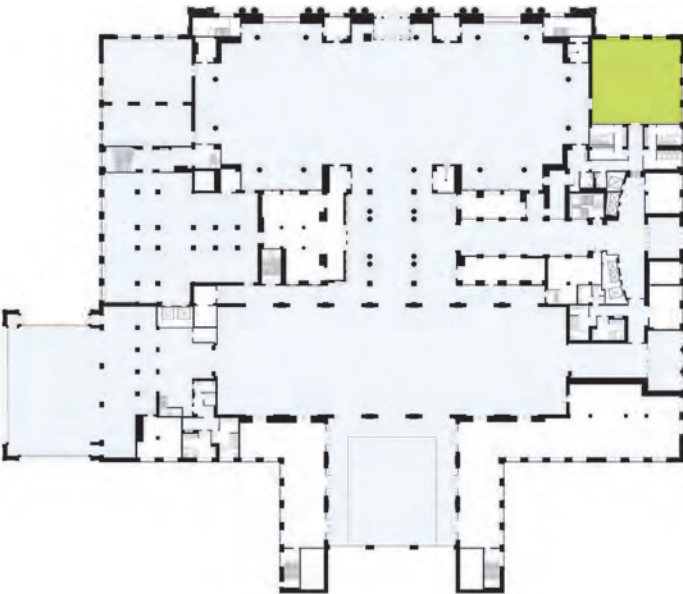
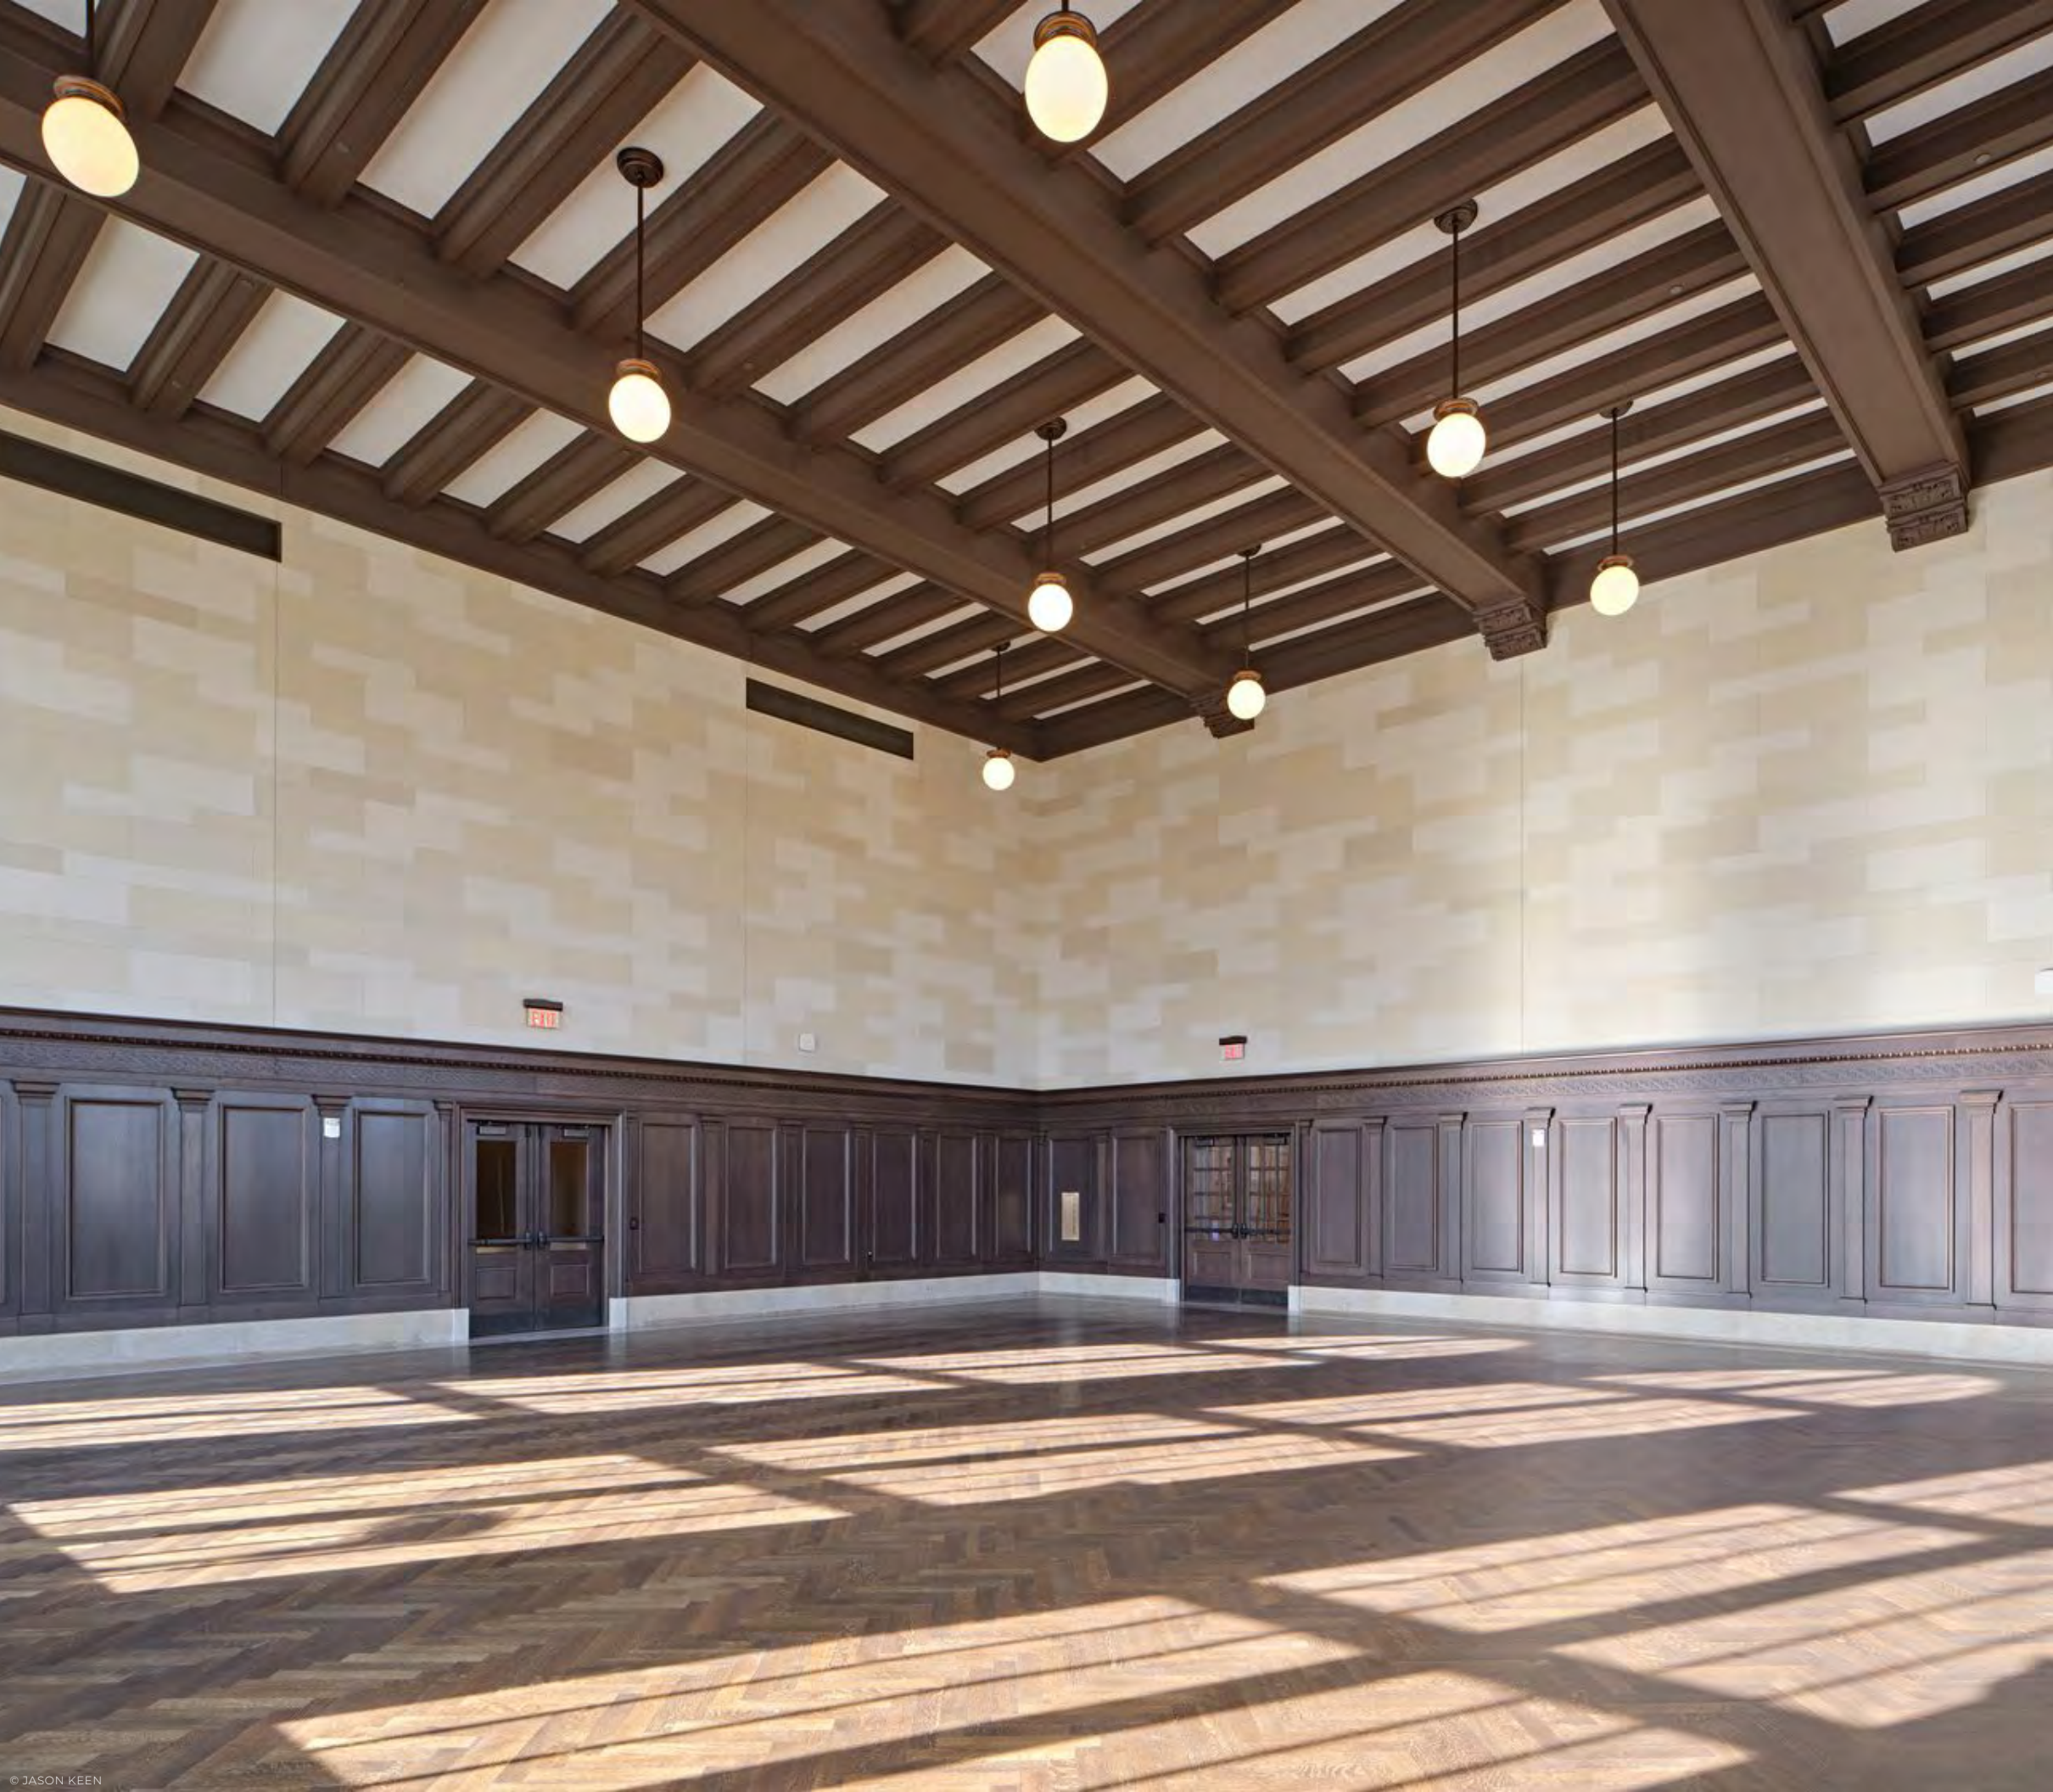
# WOMEN'S WAITING ROOM

- **Flooring:** The original terrazzo cove and marble border were restored. The herringbone-pattern wood inlay was replicated.
- **Corbels:** One wooden corbel (the decorative element where the ceiling beams meet the upper wall), badly damaged by water infiltration from the low roof above, was used to recreate the other five, which were missing.
